REPEATED DAMAGE OF FULBARI BY-PASS ROAD: CAUSES AND MEASURES FOR RESTORATION

*Dr. Manas Kumar Mukherjee

Associate Professor of Civil Engineering, Jalpaiguri Government Engineering College, West Bengal, India

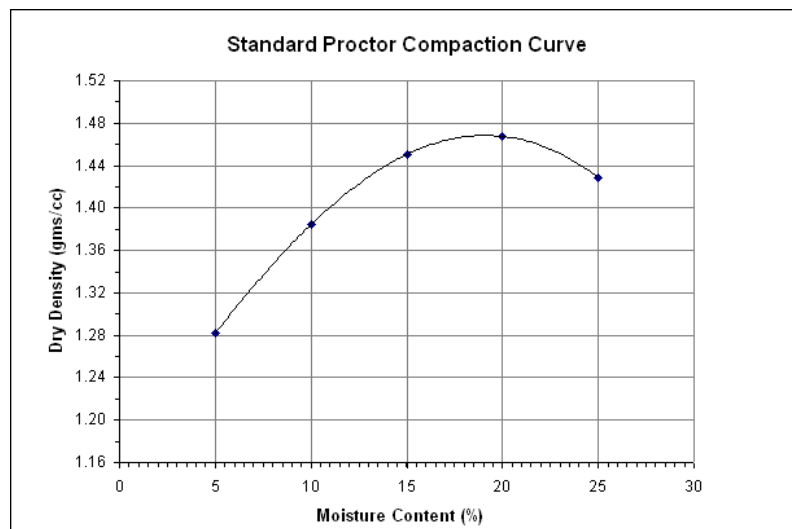
B-H-1

O.M.C = 19.00%
M.D.D = 1.47 gm/cc
