EVALUATION OF FLANGE FACE CORROSION USING PHASED ARRAY ULTRASONIC TESTING (PAUT) IN PROCESS INDUSTRY

*Gopal Sankar, R.

Research Scholar, University of Petroleum and Energy Studies, Dehradun-248007, India

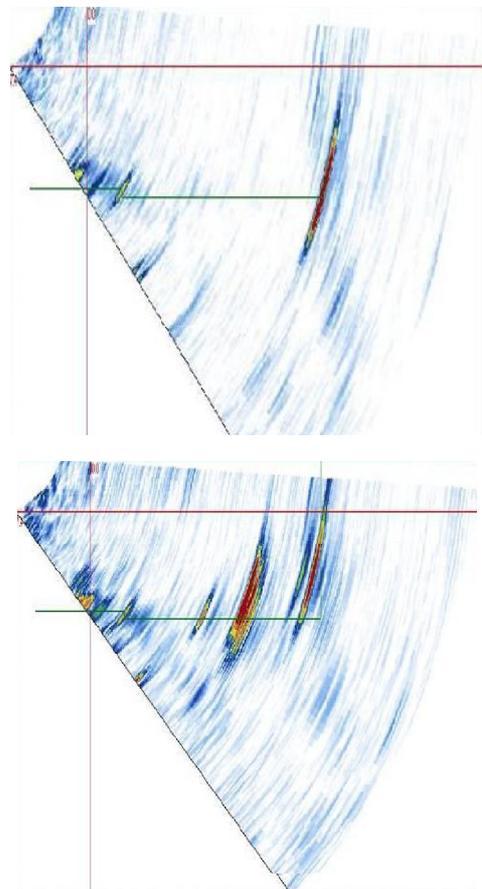
Figure 7: Use of engineering overlays

The image on the left shows no flaws with geometric reflections [5] from the face to bore corner and tip diffraction signals from the raised faced corner. The image on the right shows typical responses from areas of corrosion. Note the complete loss of corner reflector.

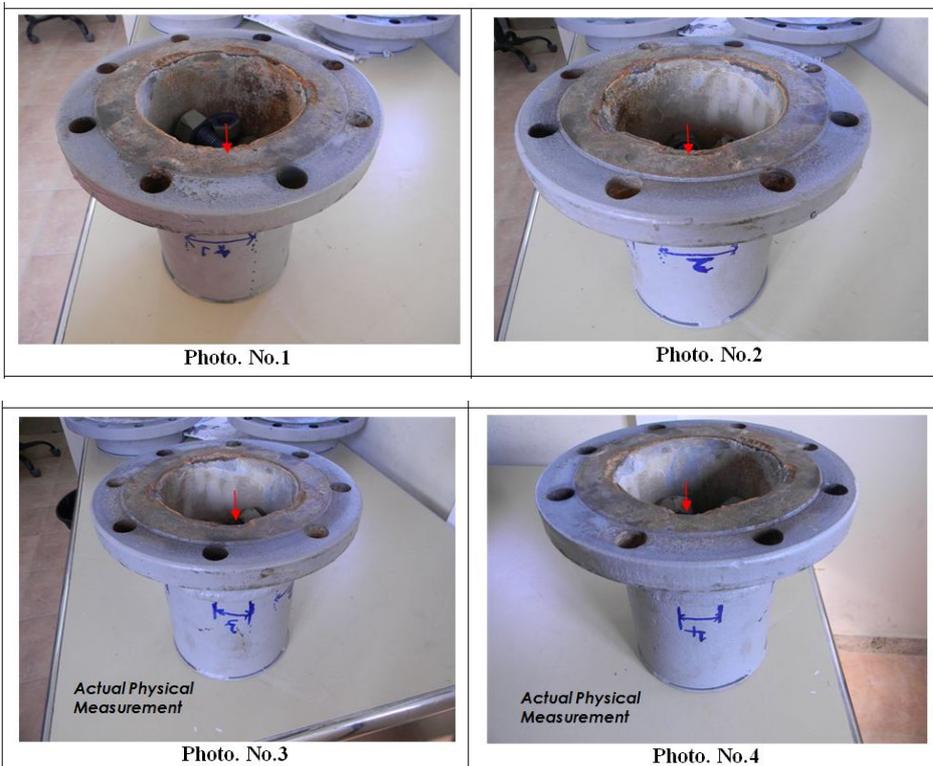
6"Mock-Up Flange Defect locations & length marked on the external surfaces of pipe correspond to actual depends when flanges were dismantled

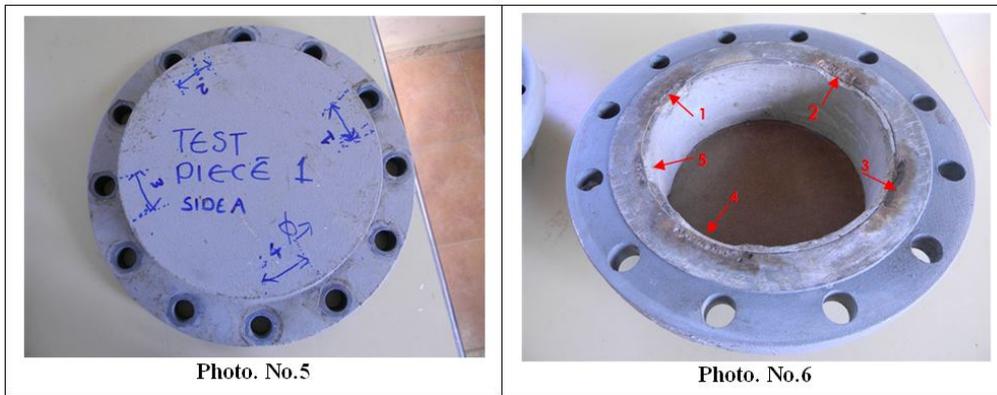
10" Mock-Up Flange

Defect locations & length marked on the external cover of pipe correspond to actual depends when flanges were dismantled.

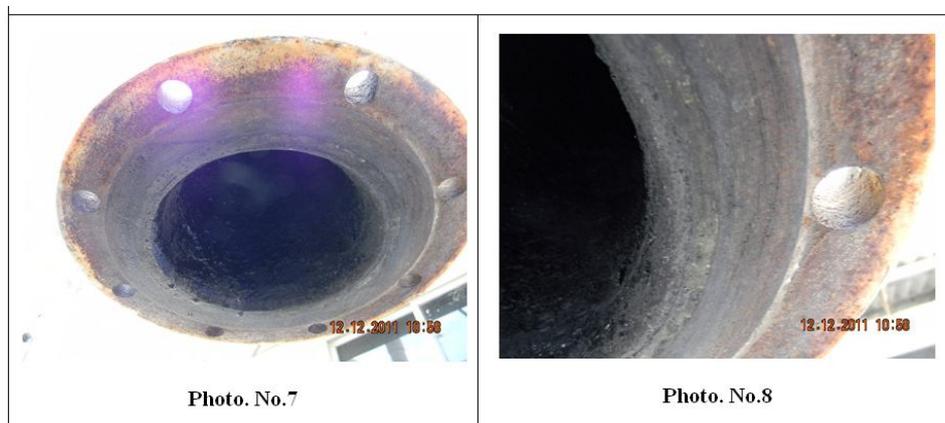
In-service flange-1 No significant deterioration noted during physical inspection as reported by Phased Arrays

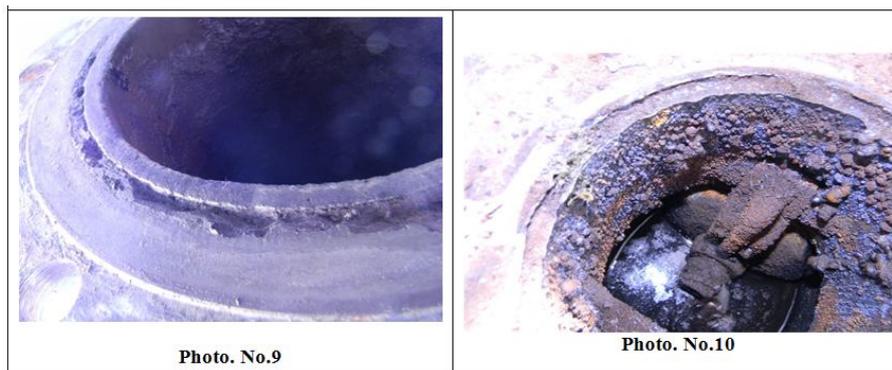
In-service flange-2 Corrosion wastage on inner edge of gasket face reported by Phase Array was verified when the NRV cover was opened

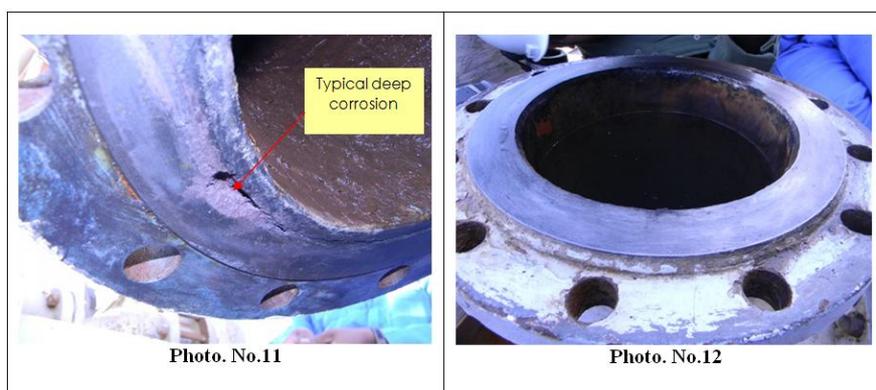
In-service flange-7 Deep Corrosion wastage on inner edge of gasket face reported by Phased Array was verified when flangejoint was dismantled and inspected. Severe wastage of approx. 16 x 12 deep on flange face at flange/cement lining interface.

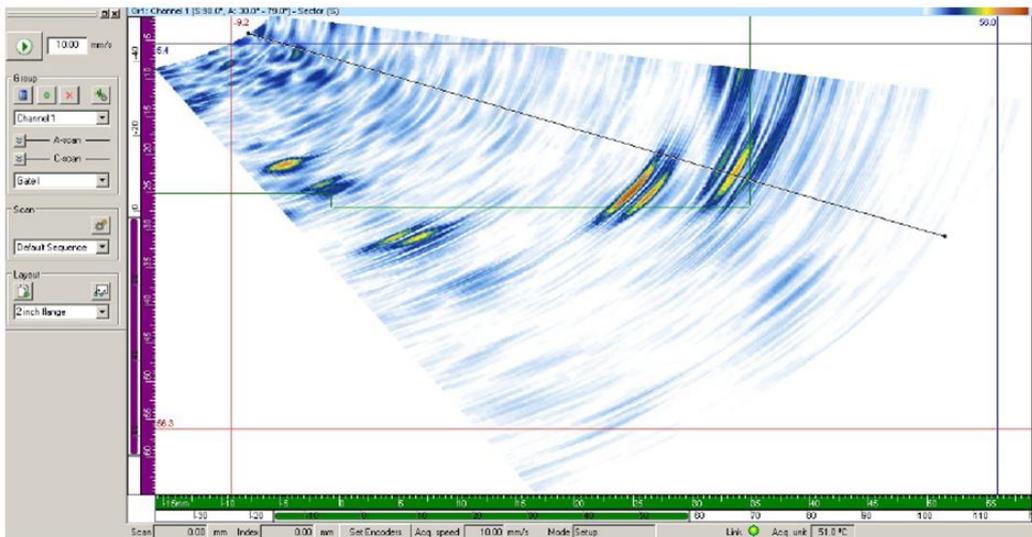
Area of damage – Mock-up Flange 1- Image 2

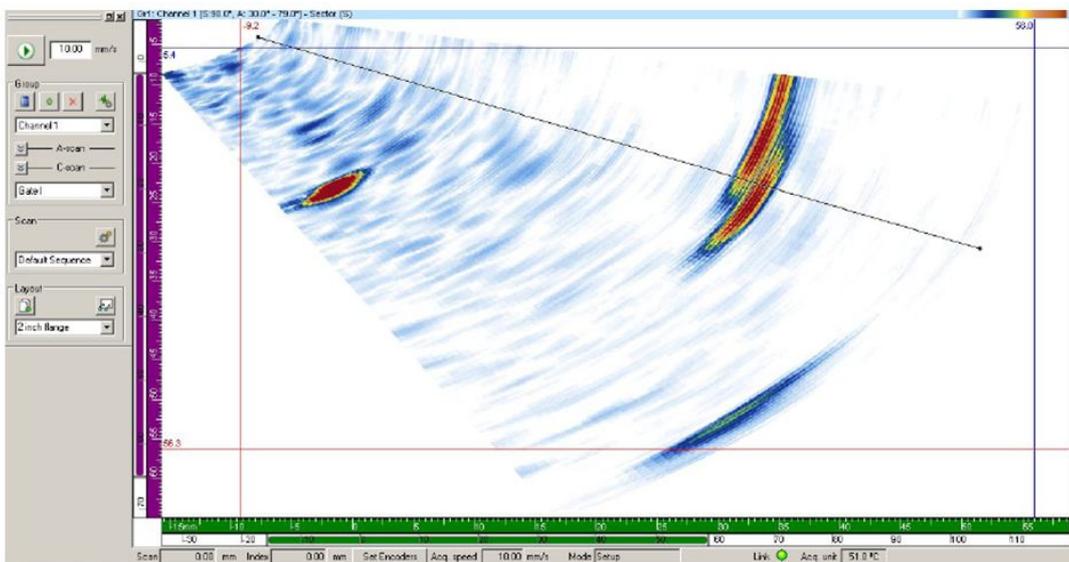
Area of damage – Mock-up Flange 1- Image 3

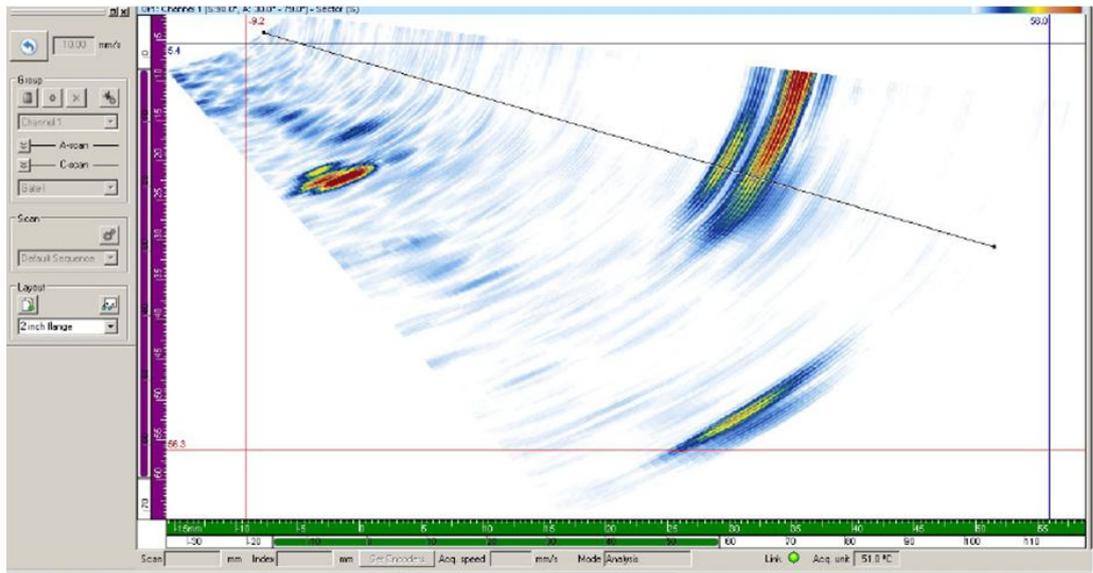
Area of damage – Mock-up Flange 1- Image 4

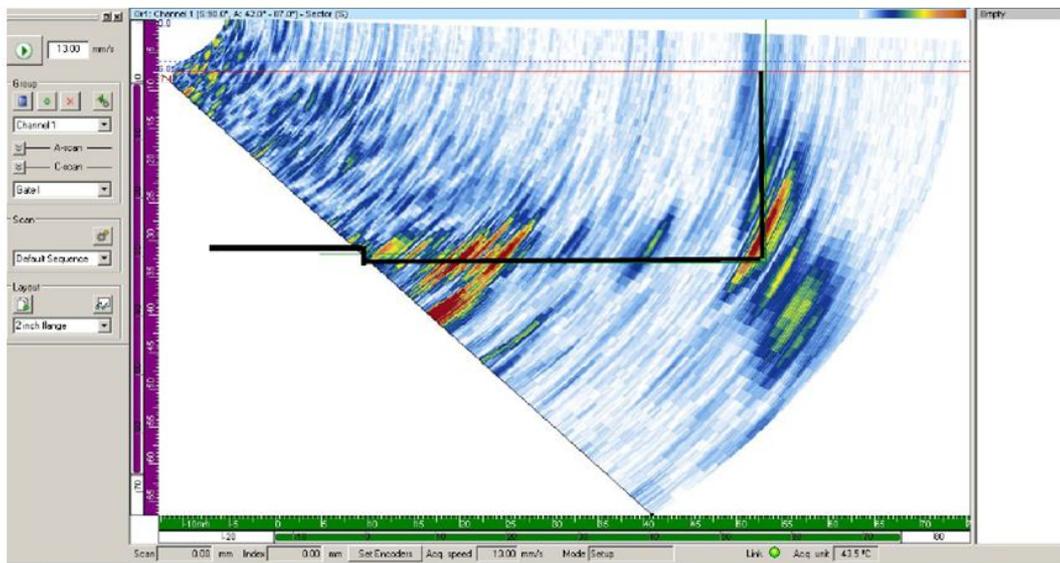
Area of damage – Isolated pit-In-service flange 1- Image 5

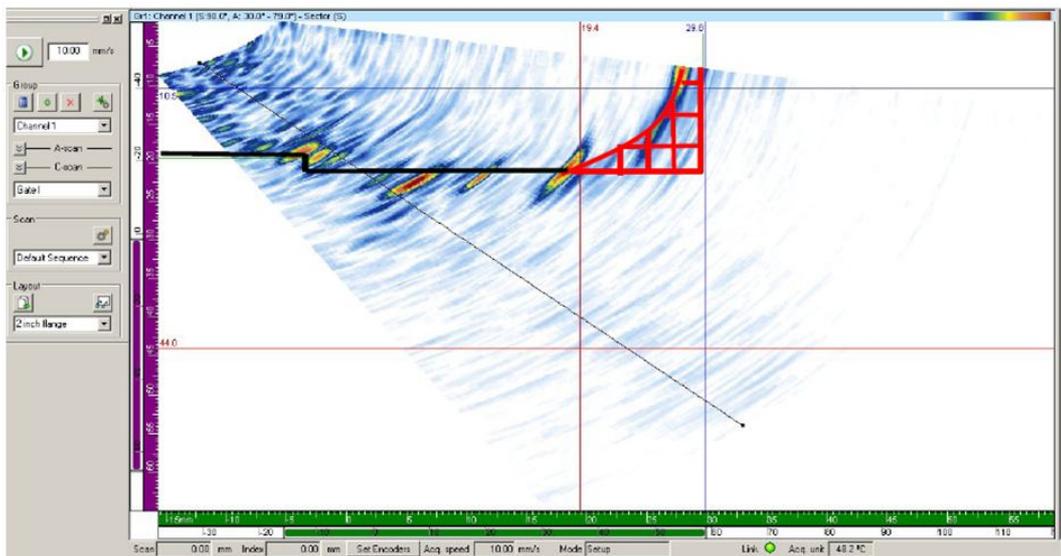
Area of damage – deep corrosion -In-service flange 1- Image 6

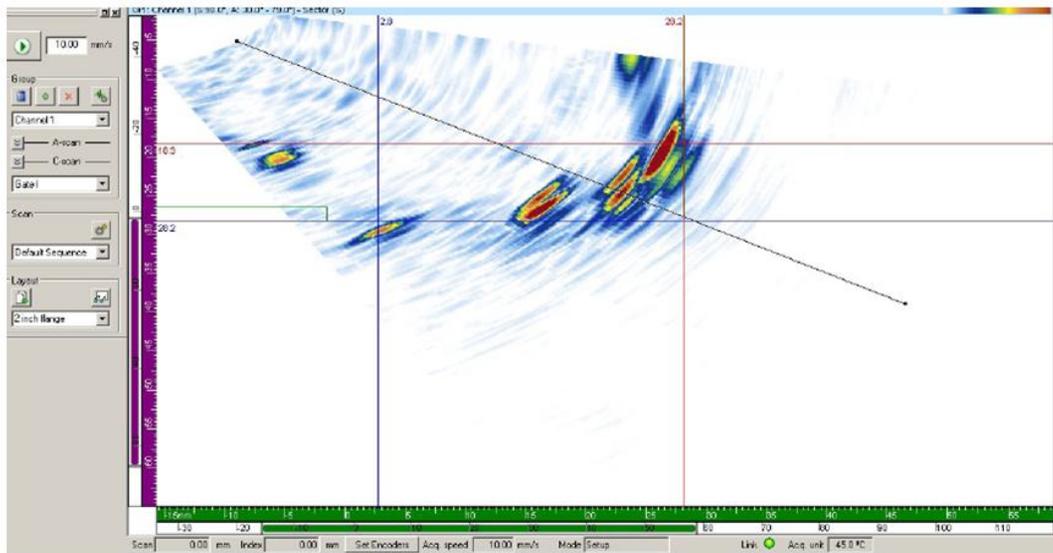
Area of damage – deep corrosion -In-service flange 1- Image 7
