### USE OF RPAS (DRONES) FOR MASONRY ARCH BRIDGES INSPECTION: APPLICATION ON GRAJAL BRIDGE

The bridge inspected was the “Puente del Grajal” (Fig. 1). It is a Bridge located at the following coordinates:

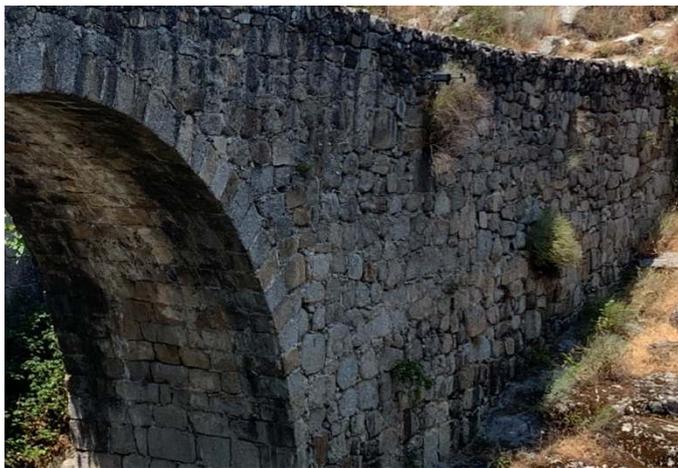
This vegetation enters into feedback with the phenomena of humidity, efflorescence and runoff water, according to what the observed stains reflect (for example, the black spots we observed in the spandrel wall, Fig. 3). Special care must be taken with vegetation, especially the larger ones, due to the action of tree roots and other plantations on the factory (21). Drone can help us to control the vegetation appearance and the plants growth. The damages previously collected are not structural damages. They are damage related to the durability of the materials that make up the construction. In other words, they are not injuries that affect the integrity of the monument, at least in the short term. However, they are injuries that can end up in more serious damage if they continue to develop. Proof of this are the sandstone voussoirs. When we talk about damage related to the durability of the material that makes up an element, we refer to damage that arise from the interaction of deteriorated material with the environmental conditions imposed by it. In other words, the material durability must be understood as the material ability to resist the environmental action. It includes all chemical, physical and biological attacks, or every other environmental process that tends to deteriorate the material. The presence of efflorescence indicates two important aspects (20) (21): the first one, in some masonry, a process of chemical degradation is taking place, in principle not very dangerous. The second of them, important internal mechanical stresses due to the crystallization of the salt may be generating, depending on the masonry porous system. Drone can help us, through subsequent inspections, to study such pathologies. When two (or more) old and heritage buildings are close together, they are made of the same materials. This is due to the transport limitations that existed in the past. This fact made this construction especially interesting: the 19th century bridge erected next to the medieval one, with identical materials, should have suffered the same damaging processes, although to a lesser extent. Indeed, the drone allowed to corroborate the above. The vault of the nineteenth-century bridge showed the same injuries, although with different intensity (Fig. 9): black crusts, runoff water marks and efflorescence. On the walls, there were also black crusts and runoff water traces, in synergy with vegetation rooted in the joints between ashlars (Fig. 10). The only injury of this bridge, which was not included in the old Bridge, was an anthropic vandalism injury: a graffiti on the east abutment wall (bottom left of Fig. 9). It is a damage to take into account, given the deterioration caused by the graffiti products (41).

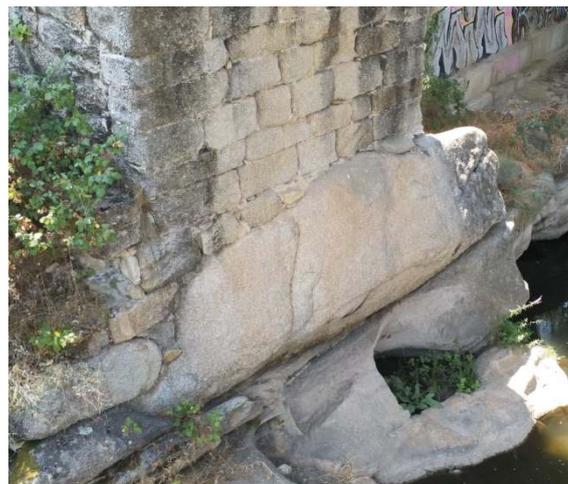
Once the inspection began, the first thing was to analyze the foundation. The drone allowed us to approach it, because here it was partially visible (Fig. 4). Thus, we have been able to verify that the abutments of the bridge rest on a base of granite, a material identical to that which makes up the masonry of the bridge. The foundation and the base of the vault were in good condition (Fig. 4). The drone was useful for a detailed visual inspection of the foundation (at least, the visible part). Thanks to this, we were able to verify that the bridge is effectively founded directly on solid rock. It was the usual procedure in the Middle Ages (19). In addition, with the incorporated technology, the aircraft can estimate the type and dimensions of the foundation element and help us with other important operations in this type of structure, such as approximate estimation of the type of terrain, estimation of the longitudinal profile of the riverbed, estimation of the cross section upstream and downstream of the bridge, determination of the degree of cleanliness of the channel and setting out of the drag elements in it. After analyzing the foundation, we continue with the structural inspection of the rest of the elements. The most interesting point was the vault intrados. The intrados is interesting because of the damage found on it and it is also interesting because of its inaccessibility. In order to carry out a complete visual inspection of the intrados, we would need to enter the river, swimming or sailing on a boat. But in none of these cases could the level of approach to the top that the drone allows be achieved. The monument constitutive granite presents deteriorations in the intrados, due to the actions synergy of diverse nature: chemical nature phenomena and biological nature phenomena. Thus, we observe various black crusts formation, especially in the outer ashlar (Fig. 5 y Fig. 6), presumably linked to the contaminating agents action and

**Fig. 4. Photograph taken with the drone, where the found ations of the eastern abutment of the Medieval Bridge can be seen (photograph taken by the autor)**

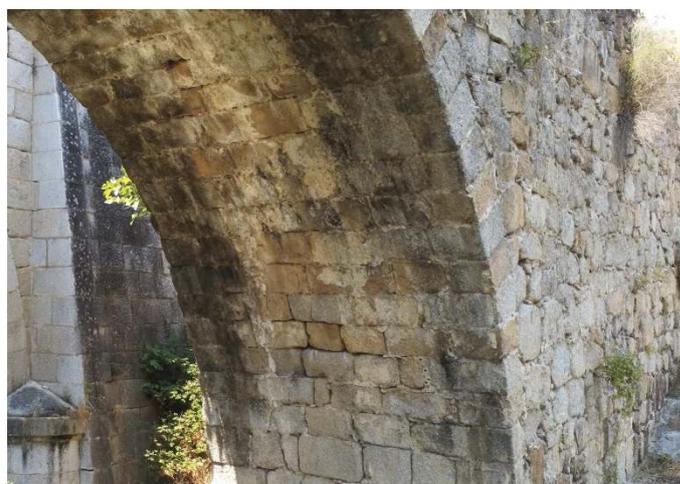
The use of lime mortar in the last restoration could have increased this damage. In addition to the dark crusts, we can see blackening spots. This damage is characteristic of structural elements exposed to high humidity as well. These stains result from the joint action of water (humidity), the crystallization of salts provided by contaminating agents and granite masonry (20). The inspection allowed to locate efflorescences in the intrados vault central area. They were those whitish spots that we can observe (Fig. 5 y Fig. 6). Efflorescences usually appear around areas where there is a high concentration of humidity as well. In this case, the cause of efflorescence seems to be related to the use of lime mortar as well (20). Thus, every microcrack that appears on the lime mortar joints can become an open door for water access to the interior of the masonry. As the Bridge is in a humid environment, there is much more water and, therefore, the amount of water that enters the masonry through the joint is greater (21).

**Fig. 5: Image captured with the quadcopterdr one at the western start of the vault, where various lesions can be observed, such as efflorescencesordarkcrusts (photograph by the autor).**

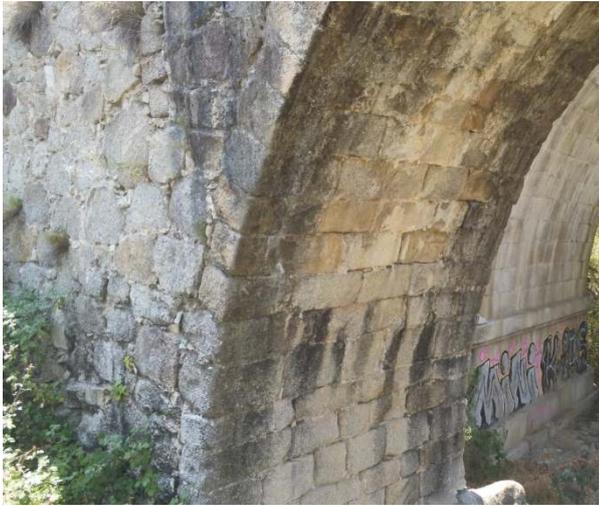
**Fig. 6:** Image captured with the quadcopterdr one at the eastern start of the vault, where various lesions can be observed, such as efflorescence or dark crusts (photograph by the author)

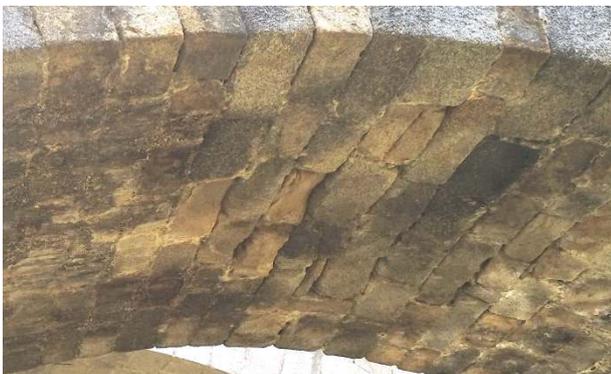
joint points of the Bridge (Fig. 7). This is the best proof that these micro cracks exist in the mortar joints. The most curious thing of all, is that this mortar was used to restore surely to prevent plants from taking root between the masonry (21).

We must remember that crusts and especially efflorescences are result from salts crystallization. These salts tend to agglutinate around points where high concentrations of moisture occur. This anomaly is produced by soluble salts crystallizing, dissolved in the granite porous system (20). The drone was effective in detecting efflorescence and in detecting possible salt (22) sources as well (coming from the masonry itself or from external agents-pollution, materials from previous interventions, etc.). In the upper part of Bridge intrados, in addition to the aforementioned damage, we discovered, thanks to the drone, the blistering and sanding of several voussoirs (Fig. 7). This alveolization process is directly related to the previous processes: humidity and salts can cause this deterioration as well. Generally, this appears at the confluence of internal waterways (from the extrados to the intrados, through the fill, due to poor drainage) with the erosive action of the wind (21). Therefore, they are located in exposed areas where moisture accumulates, as is the key to the vault. There, the exit routes of the internal water and the desiccation surface joint. Once the process is started, the eddies of wind in the cavity accelerate it (20).

**Fig. 7:** Image captured with the quadcopterdr one in the intrados of the upper part of the vault, where in addition to the previous injuries Fig. 5 y Fig. 6 we observed vesiculation of ashlars (author's photograph)

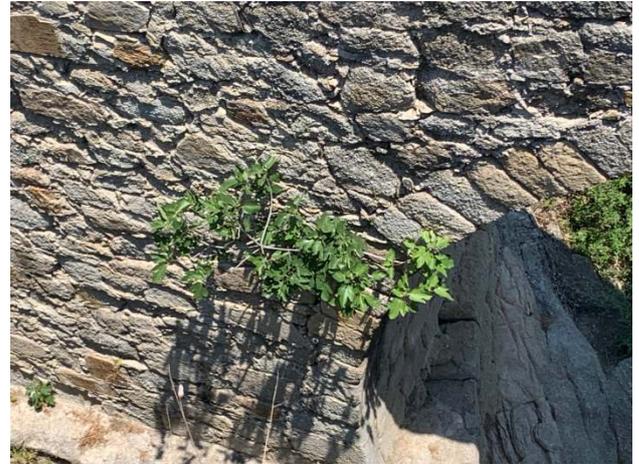
Along with these damages, we observe abundant presence of biocolonies (plants). They have grown taking root in the joints that are arranged between the masonry, especially in the joints of angular points (Fig. 8).

**Fig. 8:** Image captured with the quadcopterdrone, where you can see vegetation (a fig tree) rooted in the joints of the masonry (photograph by the author)

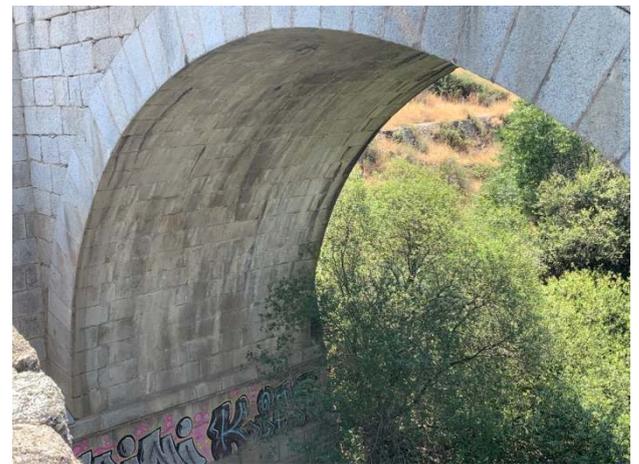
**Fig. 9:** Image captured with the quadcopterdr one in the intrados of the vault of the new bridge, with lesions identical to those of the medieval bridge being observed: efflorescences or dark crusts (photograph by the author)

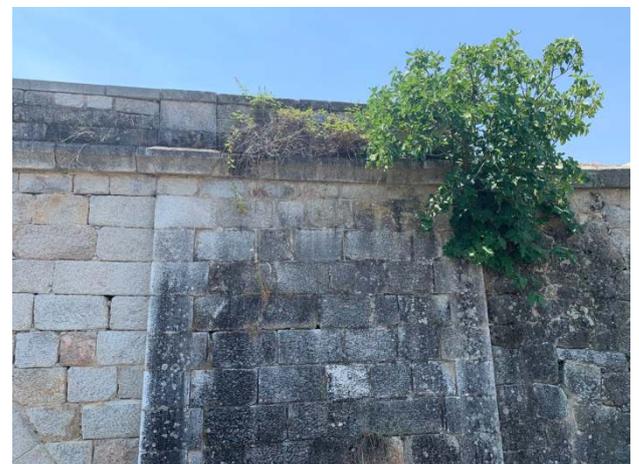
**Fig. 10:** Image captured with the quadcopterdrone, where a detail of the west abutment can be seen, with root edge vegetation, black crusts and run off watermarks (photograph by the author).
