STATE OF HYDRAULIC INFRASTRUCTURES FOLLOWING SUCCESSIVE FLOODS IN THE IRRIGATED AREA OF ANEKER-TAHOUA-NIGER)

This study was carried out on the irrigated area of Aneker, Tahoua region (Niger), the objective of which is to analyze the physical state of hydraulic structures following flooding on this development. Its objective is to make an exhaustive diagnosis of the irrigation and drainage networks. The methodology consisted of the development of two (2) survey sheets, one of which was administered to irrigators and the other with ONAHA technicians. The other was used to explore a certain number of hydraulic works such as irrigation canals, protection and drainage networks, in order on the one hand to assess the physical state of these works and on the other hand to complete data collected with operators and technicians. Thus, the collected data was processed and analyzed. The results of this study show a notable deterioration of hydraulic infrastructure which affected the operating performance of the study area and development. It emerges from this study that the perimeter is faced with the problems of cracking observed on the canals, the lack of seals, the degradation of the jump

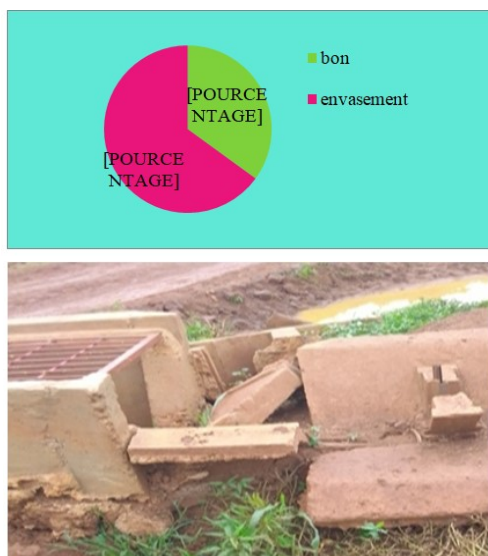
Figure 1. State of intake structures on the Aneker irrigated perimeter

There are a few intake structures of which 65% are in a state of siltation or even cracked and 35% are in good condition as illustrated in Figure 1.

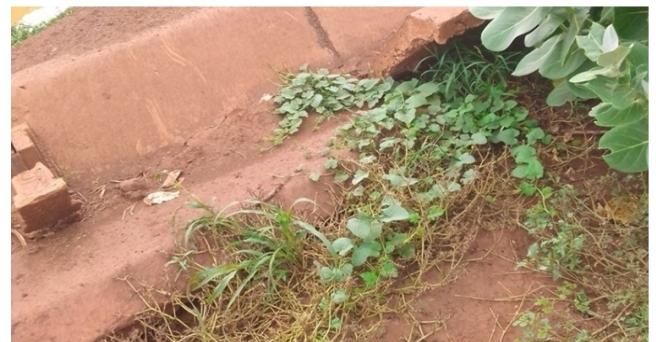
Main channels: The water distribution works are in poor condition, especially the primary and secondary canals which are currently in various degraded states. The main canals present anomalies, most of which are either broken, detached, loose, cracked or good as illustrated in Figure 2.

Figure 2. Condition of a portion of the main canal at the Aneker irrigated perimeter

The table below shows on the main channels the stresses most observed are cracking and defective joints to a very poor degree on the other hand breakage and jumpers degraded to an average degree (Table 2).

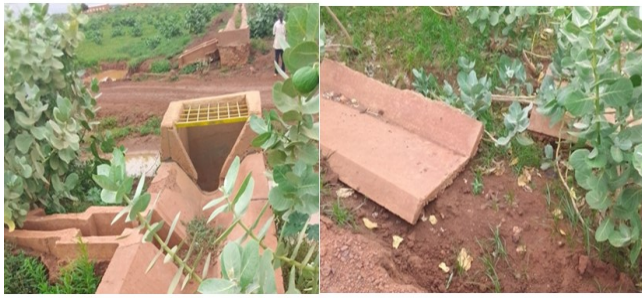
Secondary channels: At the level of the Aneker irrigated area, the observation is that most of the secondary canals are in a seriously degraded state. The table below shows on the secondary canals the constraints mainly observed are cracking, weeding, defective seals and the degradation of the valves to a very poor degree while the degradation of jumper and the presence of termite mounds are to a degree average (Table 3).

Figure 3. Condition of secondary canals in the Aneker irrigated perimeter

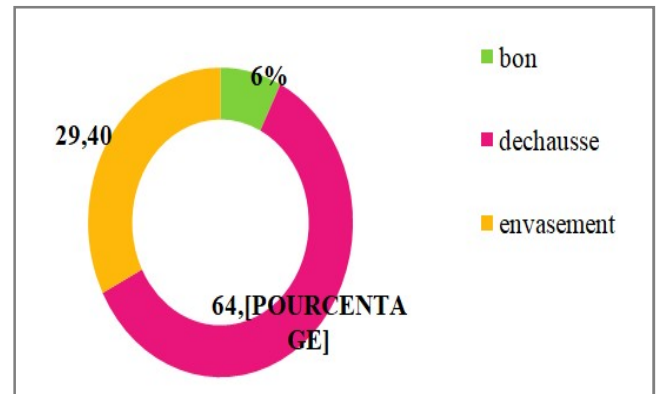
Figure 4. State of protection network (dykes) on the Aneker perimeter

Protection network: dikes: The protective dikes have the essential role of ensuring the protection of the water perimeter. Following the floods of 2020, the dikes of the said perimeter gave way and there is currently no protective dike on this perimeter. Although they are ceded, we also note their state of loosening, siltation and good condition. Figure 4 illustrates that 64.60% of the dikes are exposed, 29.40% are victims of siltation and 6% are good.
