CASE STUDY

FURCAL PERFORATION REPAIR WITH BIODENTIN: ONE YEAR FOLLOW UP OF A CASE

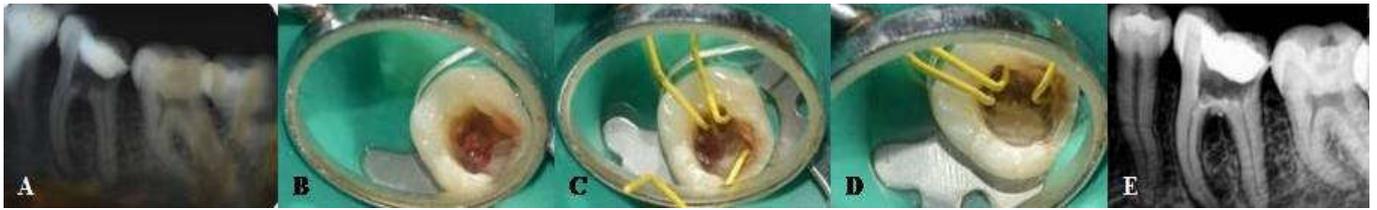
A healthy 35yr-old female was referred to the Department of Endodontics, Goa Dental College and Hospital with chief complaint of pain in the lower left first molar since two days. Patient gave a history of initiation of root canal treatment at a private clinic two days back. Clinical examination showed mild tenderness to percussion and palpation test. The mean probing pocket depth was within normal limits. The radiographic examination showed a slight radiolucent area in furcal region of tooth 36. Based on patient clinical and radiological examination Iatrogenic furcal root perforation was diagnosed. Treatment procedure was explained to the patient and informed consent obtained before the root canal treatment was initiated. Profound anesthesia was given. The tooth 36 was isolated using a rubber dam. The temporary dressing was removed. Approximately 2 mm, circular furcal perforation was seen on the lingual aspect of the tooth. There was bleeding on probing at the perforation site.

Figure 1. (A) Radiograph showing perforation in 36 at Furcal area. (B) Furcal perforation in 36. (C) Canal orifice temporarily blocked with gutta-percha. (D) Furcal perforation sealed with biodentin. (E) RVG image of sealed perforation

Soft tissue growth through the perforation site was extirpated with the help of a sharp instrument. Hemorrhage was controlled with copious irrigation with small cotton pellet soaked in normal saline. Perforation area and pulp chamber were cleaned with normal saline solution. Mesio Buccal, mesiolingual and distal canals were blocked temporarily with gutta-percha cones (#20, 2%). Ab-gel (Sri Gopal Krishna Lab, Mumbai, India) was placed in perforation site to provide an internal matrix for Biodentin placement. Biodentine was manipulated in an Amalgamator for 30 seconds and the material was carried to the perforation site using an amalgam carrier. The material was then adapted to the cavity with a cotton pellet without pressure. Once the material had set any excess material was removed with a curette. Gutta-percha points which were temporarily placed in the root canal were removed. Working lengths of the canals were determined with an Apex locator (Propex II, Dentsply, Maillefer Ballaigues, Switzerland) and confirmed radiographically. The mesial and distal canals were cleaned and shaped using Protaper files (Dentsply Maillefer, Ballaigues, Switzerland) in a crown-down technique with 5.25% sodium hypochlorite irrigation. The root canals were then obturated with gutta-percha points and AH plus (Dentsply, DeTrey Konstanz, Germany) using the lateral condensation technique. The tooth was temporary filled with

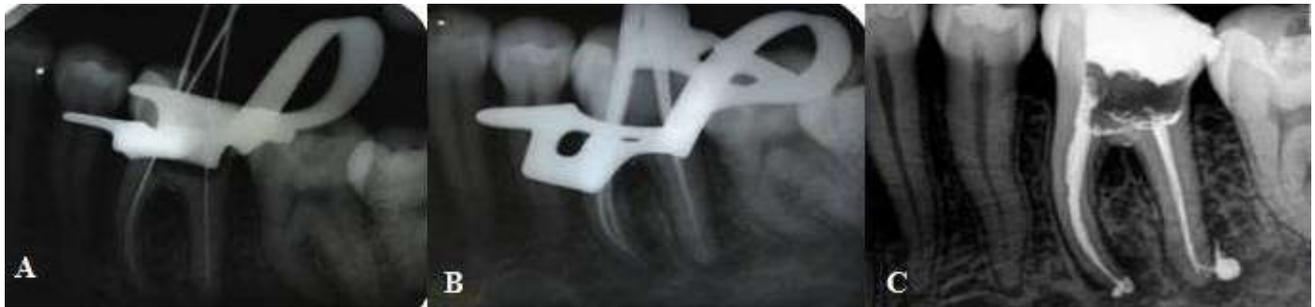
Figure 2. (A) Working length confirmation. (B) Master cone image. (C) Post-obturation RVG image

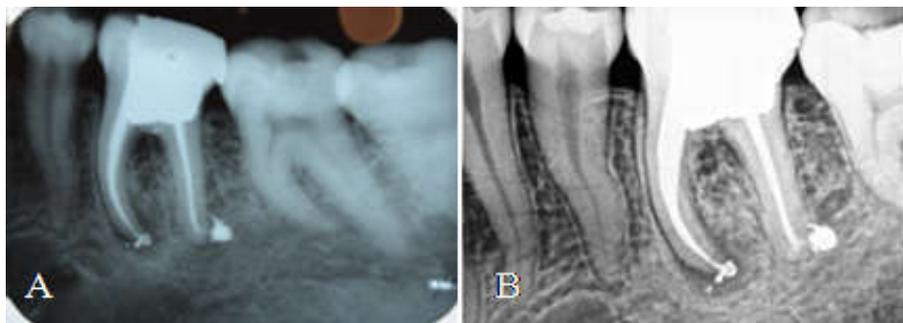
Figure 3. (A) Three months follow up. (B) One year follow up

Cavit temporary restoration material (Cavit-G, 3M ESPE, St. Paul, Minnesota, USA) and patient recalled for follow up after a week. Patient did not complain of any type of sign or symptom related to that tooth. Permanent restoration was completed for the same tooth and patient recalled after three months and one year for check up.
