RESEARCH ARTICLE

RIVER BANK EROSION AND ENVIRONMENTAL NEO-REFUGEES: A CASE STUDY OF  
MURSHIDABAD DISTRICT IN WEST BENGAL, INDIA

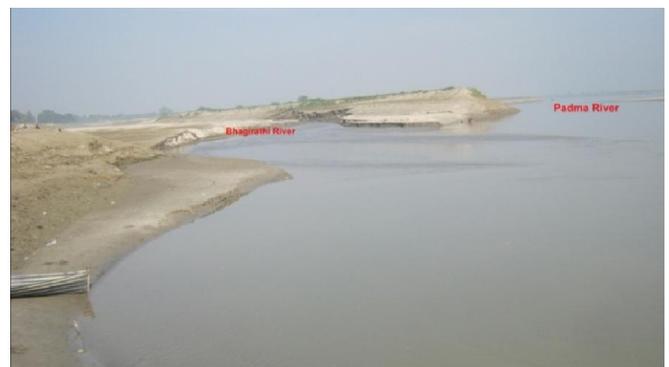
Plate I. Confluence of Padma and Bhagirathi River at Mithipur

Most of the dams in India are constructed due to irrigation purposes, but construction of Farakka Barrage is different purposes. The Farakka Barrage (2.64 km long) was designed to divert 40,000 of Ganga water towards Bhagirathi River through feeder canal to save the Kolkata port. The interface of the Ganga regime by construction of the Farakka Barrage give many hydrological and morphological changes such as changes of water level, discharge, sediment movement, bed slope character etc. Prior to the constructon of Farakka barrage, the Bhagirathi River is originated from the Padma River near Mithipur and water flows from Padma to Bhagirathi River. After construction of Farakka Barrage and feeder canal, small amount water from Bhagirathi River flows toward Padma River through small channel (Plate I).

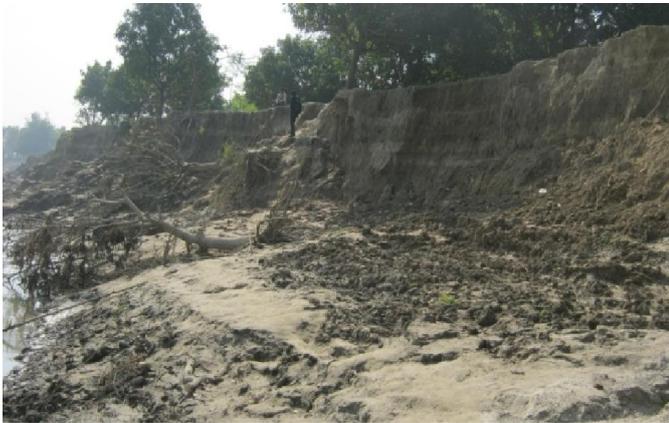
**Plate III. Mango garden at Mithipur washed away due to Padma River bank erosion**

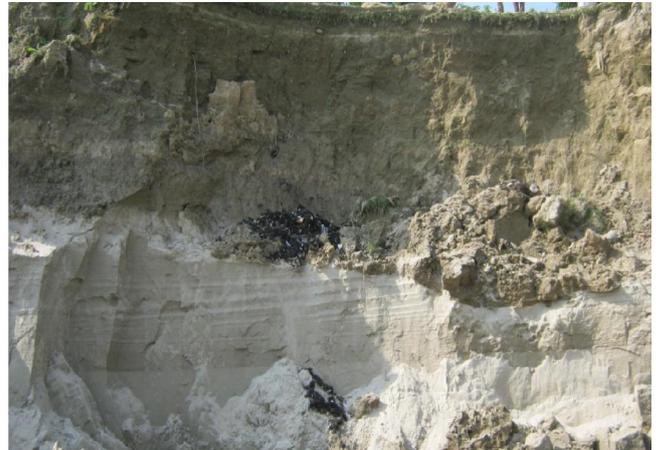
**Plate IV: Unconsolidated sand at bottom and thin silt clay soil at top at Mithipur area**

2. Stratigraphy of bank composed of micaceous unconsolidated sand at bottom and thin silt clay at top causes severe bank erosion (Plate IV).

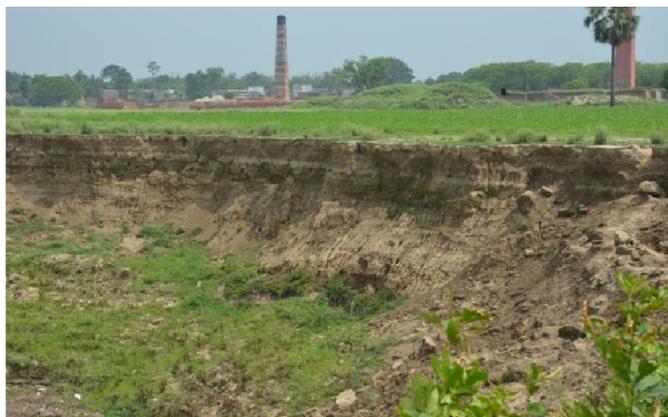
Plate V. River bank erosion and brick field along Padma River bank at Maya

7. Anthropogenic activities along bank side such as digging of the land for preparation of brick, furrowing of land for cultivation, construction for habitation etc. also accelerate the process of river bank erosion. Brick field are concentrated in different parts of Murshidabad district along the bank side of the Padma and Bhagirathi River (Plate V). Digging of land on the river bank at Dhulian and Maya and other places by land mafia. Apart from the 2.64 km. long Farakka which was built across the river during 1962-1971, bank revetment with boulders, construction of the spurs to deflect the impinging current, the flood control embankment, excessive withdrawal of ground water are all combine causes for river bank failure.

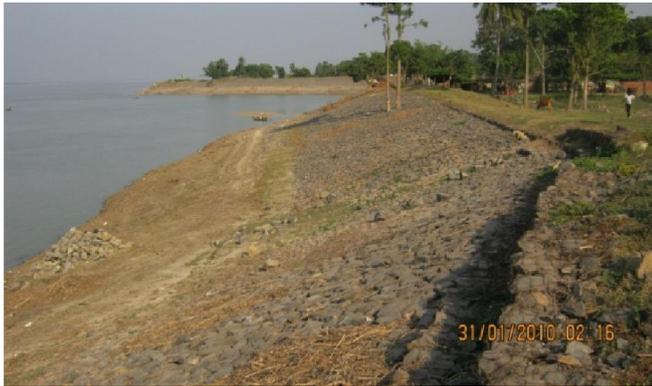
**Plate VIII. Padma River bank protection through boulders with weir nets**

1. River bank erosion must be control as far as possible to protect the environmental neo-refugees through engineering measures such as concrete spurs, sand filling bags, boulders with weir nets etc (Plate VIII).

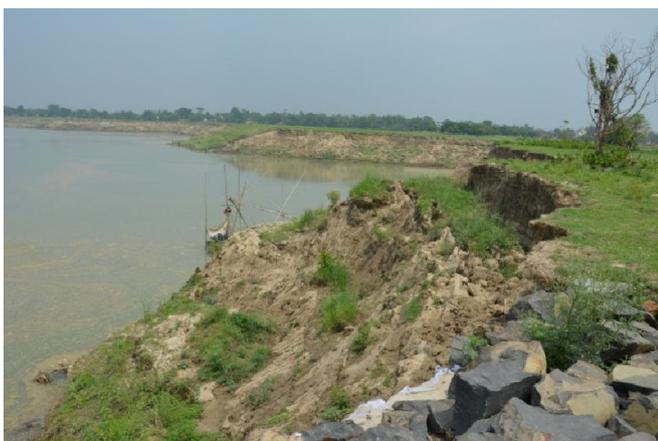
**Plate IX. Bank protection by boulder washed away along Padma River bank at Maya (Lalgola)**

The revetment of banks with boulders did not ensure protection, rather proved futile in many cases (Plate IX).
