International Journal of Current Research
Vol. 15, Issue, 08, pp.25631-25634, August, 2023
DOI: <https://doi.org/10.24941/ijcr.45867.08.2023>

RESEARCH ARTICLE

FUNGAL INVOLVEMENT IN BIO WEATHERING OF HISTORICAL MONUMENT WITH REFERENCE TO BATESHWAR HINDU TEMPLES, MORENA TOWN OF MADHYA PRADESH, INDIA

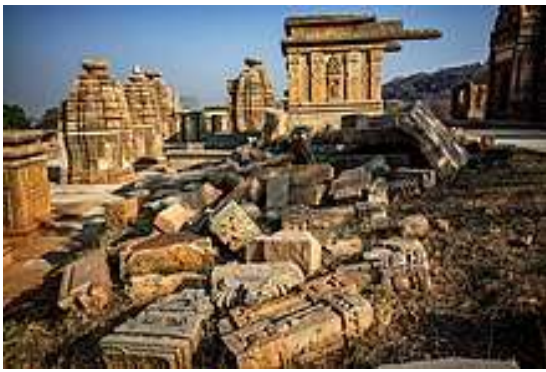
Fig. 1. Three floor plans at the Bateshwar site

History of Bateshwar Hindu temples: The Bateshwar Hindu temples are a group of nearly 200 sandstone Hindu temples and their ruins in north Madhya Pradesh in post-Gupta, early Gurjara-Pratihara style of North Indian temple architecture. It is about 35 km north of Gwalior and about 30 km east of Morena town. The temples are mostly small and spread over about 25 acres site. They are dedicated to Shiva, Vishnu and Shakti - representing the three major traditions within Hinduism. The site is within the Chambal River valley ravines, on the north-western slope of a hill near Padavali known for its major medieval era Vishnu temple. The Bateshwar temples were built between the 8th and the 10th-century. The site is likely named after the Bhuteshwar Temple, the largest Shiva temple at the site. It is also referred to as Batesvar temples site or Batesara temples site. The Bhutesvara temple had a square sanctum with a 6.75 feet side, with a relatively small 20 square feet *mahamandapa*. The sanctum doorway was flanked by river goddesses Ganga and Yamuna. The tower superstructure was a pyramidal square starting off from a 15.33 feet sided square seated on a flat roof and then rhythmically tapering off¹.

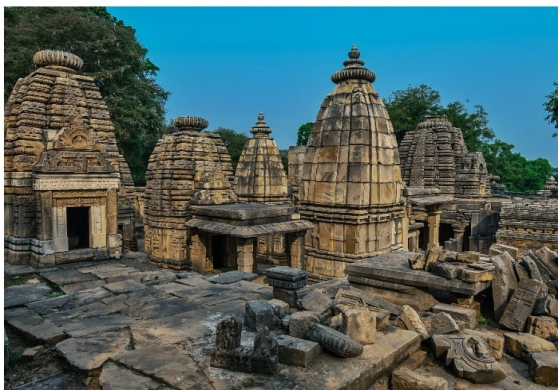
Fig. 4. Micro organism growth on the surface

Conservation issue: The Bateshwar temple is built of sand stone, which is porous in nature. The surface deposits seem to be very old due to the formation of secondary dull green pale white lichens, which are present all over the stone surface. Due to these growths of microbes, the aesthetic beauty of the temple is seriously affected. From a scientific point of view these growth of microbes are very harmful for the health of the stone surface, because these micro organisms secrete an acid that dissolves the sand stone¹¹.

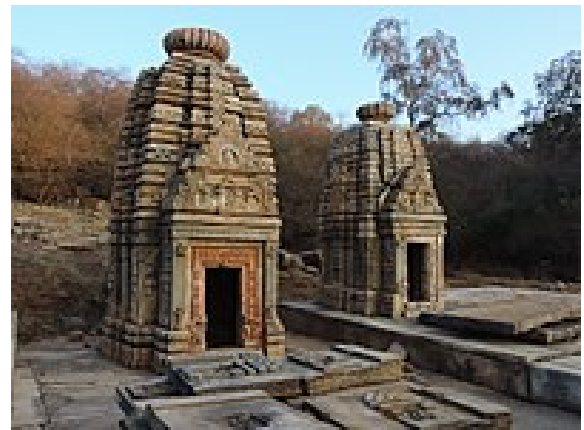
Fig. 5. Micro organism growth on the surface

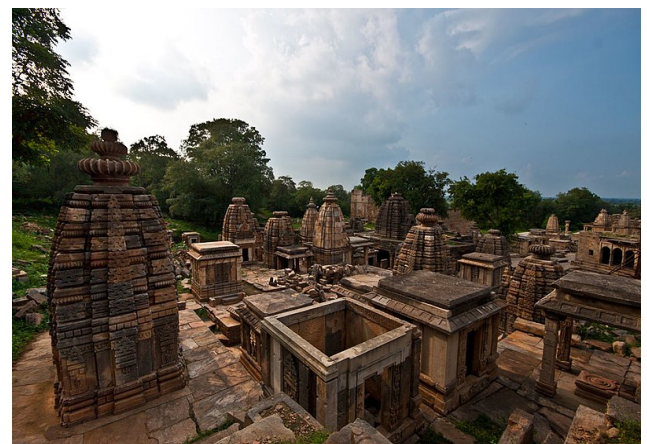
Fig. 6. Showing micro-organism growth on the monuments showing micro-organism growth on the monuments

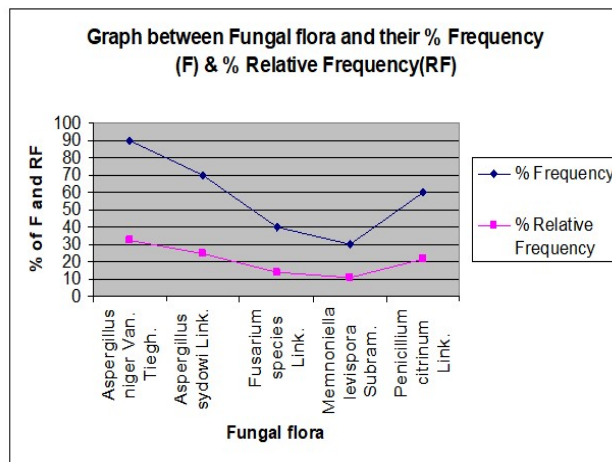
Graph 8. gungalflora and % frequency & %RF

Isolated Fungal Organism	S ₁	S ₂	S ₃	S ₄	S ₅	S ₆	S ₇	S ₈	S ₉	S ₁₀	F%	RF%
<i>Aspergillus niger</i> Van. Tiegh.	+	+	-	+	+	+	+	+	+	+	90	31.03
<i>Aspergillus sydowi</i> Link.	-	+	+	+	+	-	+	+	-	+	70	24.13
<i>Fusarium species</i> Link.	+	-	-	+	-	-	+	+	+	-	40	13.79
<i>Memnoniella levispora</i> Subram.	-	+	+	-	-	-	+	-	-	-	30	10.34
<i>Penicillium citrinum</i> Link.	+	+	+	-	-	+	-	+	-	+	60	20.68
Total											290	99.97
