RESEARCH ARTICLE

PATHOLOGY IN FLOORS AND CERAMIC TILES: A PRACTICAL APPROACH

***Mateus Bravo de Aguiar and Tiago Luiz da Costa**

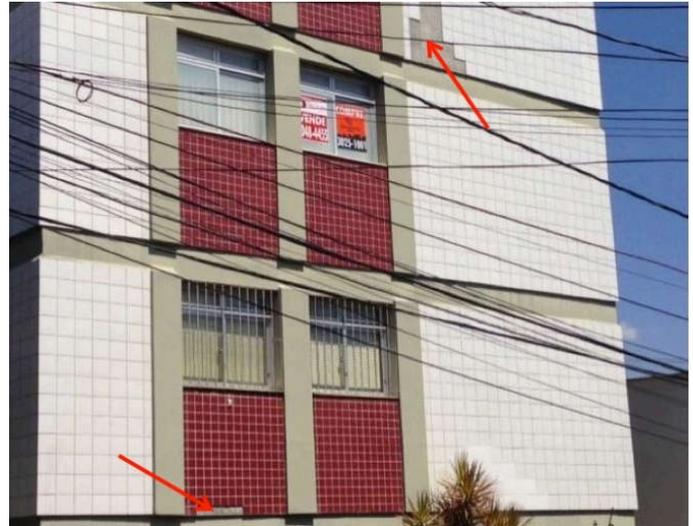
According to Barros *et al.* (1997), cited by Rhod (2011), the detachments are caused by the loss of adhesion between the layers of the ceramic coating, or between the base and the substrate (structure, masonry) of the substrate. Occurs when the tensions arising in the ceramic coating are superior to the adhesion capacity of the bindings between the mortar and the ceramic plate. According to a Campante (2003), a signal that may indicate a detachment is the occurrence of a sound dig (hollow) on the ceramic plates when impacted or the finishing layer stew. This pathology occurs in the first and last floors of the building due to the high level of tensions present in these places, as shown in Figure 1.

Figure 1. Detachment of ceramic coating on external facades

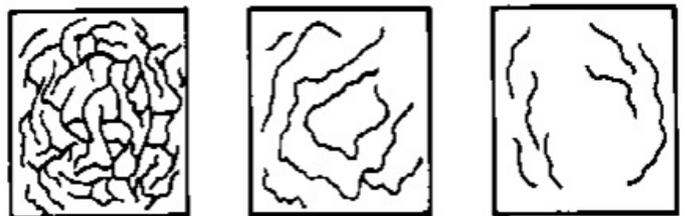
The NBR 9575 (ABNT, 2010), which refers to waterproofing, selection and design, identifies the gaps between 0.5 mm and 1 mm as cracked, the gaps between 0.05 mm and 0.5 mm are called fissures and smaller than 0.05 mm are classified as micro fissures. The NBR 13818 (ABNT, 1997), referring to the specification and methods of testing on ceramic plates for coatings, classifying the cracks in a series of apertures below 1 mm that succeed on the enameled surface of the plates, giving it a spider's web appearance, as Figure 2.

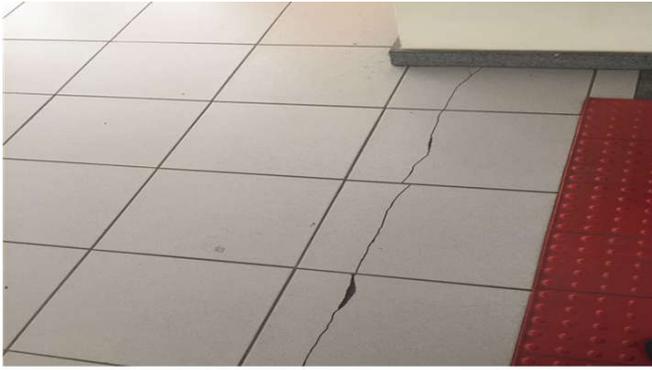
- **Excessive deformability of the structures:** creates tensions that are transmitted to the masonry and for the coating causing the cracks, fissures and cracks, as shown in Figure 3.

Figure 3. Broken due to excessive deformability

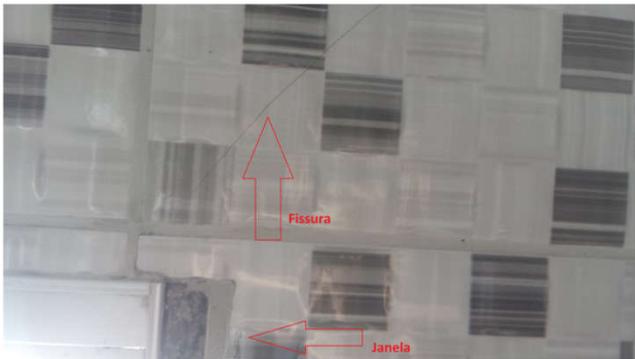
- **Absence of constructive details:** bends and bends in the openings of the windows and doors help to disperse tensions that reach the coatings, reducing the likelihood of occurrence of cracks and fissures, as shown in figure 4

Figure 4. Fissure due to absence of constructive details

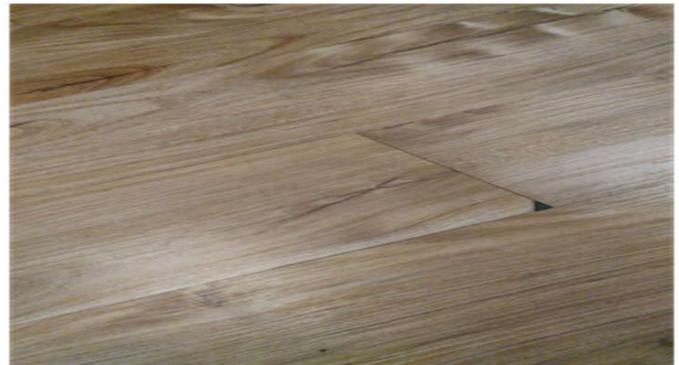
Discarding of the laminated hardwood floors of the gym. As Figures 5 and 6.

Figure 5. Displacement of the gym floor

Figure 6. Displacement of the gym floor

The hypothesis of possible causes were not conducted through visual inquiry and rather with a conversation with the owner of the academy. According to the owner, the floor plates with dimensions of (20x90) cm, are very long, so the weights of the academy when placed on a tip of the floor, ended up causing the lifting of the other end. That made those plates loose. The owner reported that the gym weights accidentally fall on those plates, which helped cause the pathology.

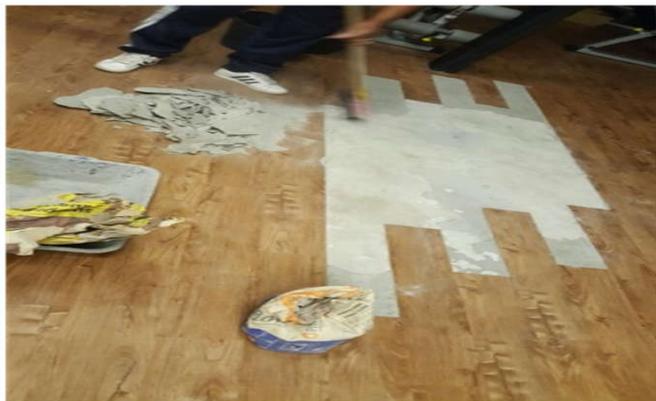
Figure 8. Cleaning the site after removing the plates

The removal of the plates that were close to those which were discarding, in the aftermath, was carried out cleaning the area (Figure 8).

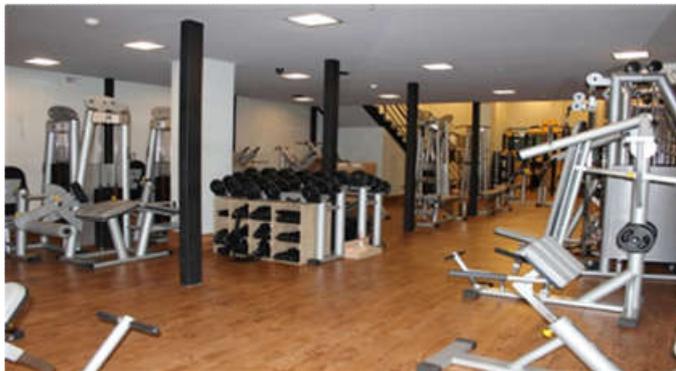
Figure 9. Academy floor restored

For repair, the industrialized mortar (AC II) adhesive was used. Observing the moisture content of the work piece to be seated and the dosage of mortar not to occur other pathologies. After maintenance, the floor is ready again, as shown in figure 9.

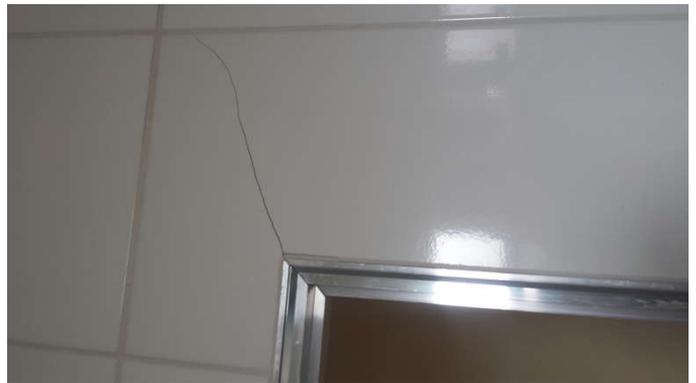
As shown in figure 10, the pathology observed is characterized, according to NBR 9575 (ABNT, 2010), as broken, as its aperture is greater than 0.5 mm and less than 1 mm.

Figure 10. Crack observed in an inner door of the building

For the formation of cracks can be considered several factors, in which it may be included: excess loads from coverage, thermal dilation and absence of constructive details. According to residents of this building, the execution phase was very troubled due to the responsible engineer, omitting constructive details at the project stage, causing the building to have a series of pathologies, among those, the observed in the coating. Ceramic. Such an argument can be convincing because, according to Thomaz (1989), the absence of constructive details such as bends and bends in the doors and windows, cause cracks, fissures and cracks. Other hypothesis for a possible cause of pathology would be the thermal movement of the mortar coating and the differential repression of the foundation.

For selecting the correct broken recovery process observed in this building, it is necessary to remove the affected ceramic coating, make a gap of the cracks in the masonry, followed by cleaning and subsequently applying a flexible product, such as an elastic sealant. Shortly after, replacing the affected part with another and taking it, probably presenting a satisfactory outcome. According to Junior (2017), the opening of vertical drive joints every 3 m or at each right foot is also of great importance.
