RESEARCH ARTICLE

RETRIEVAL OF A HEALING ABUTMENT WITH A DISTORTED HEX- A CASE REPORT

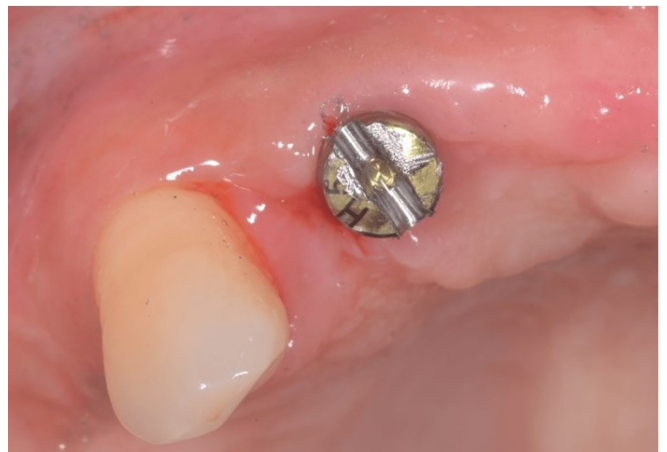
Figure 5. Slot preparation on the head of healing abutment

The reasons hypothesized by the authors for the inability to retrieve healing abutment are blood and bone debris wedged between the implant surface and the abutment, leading to cold welding. It is believed that the fibrin in the blood glues the two parts together. Dried blood, bone or any debris can also wedge in the delicate threads and thus affect the seating of the screw. In either of the situations, the cold-welded healing abutment will create a preload with the top surface of the implant that exceeds the ability to unscrew (12). Other possible reasons could be wearing out of the hex insert of the healing abutment due to multiple uses, occlusal overload in the transition phase between 2nd stage and prostheses delivery as the patient continued chewing food on the healing abutments unaware of the possible consequences, meanwhile the healing caps probably got cold welded. So in this case, a slot was created on

the surface of the healing abutment, and an appropriate screw driver was used to remove it. This technique is simple, cost effective and can be incorporated in clinical situations where the clinician does not have access to retrieval kits.

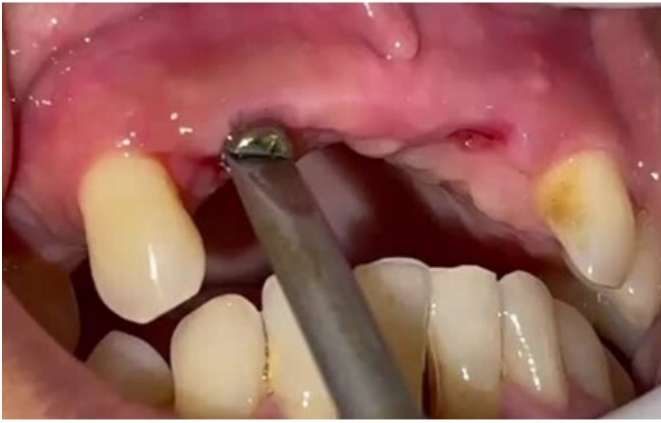
Figure 6. Screwdriver engaged into the slot and turned in an anticlockwise direction
