EVALUATION OF FLANGE FACE CORROSION USING PHASED ARRAY ULTRASONIC TESTING (PAUT) IN PROCESS INDUSTRY

*Gopal Sankar, R.

Research Scholar, University of Petroleum and Energy Studies, Dehradun-248007, India

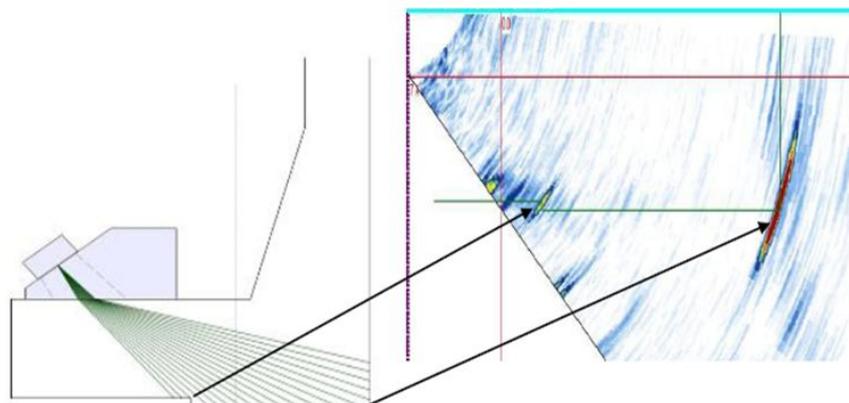
Figure 3. Showing a phased Array image generated from a defect free flange

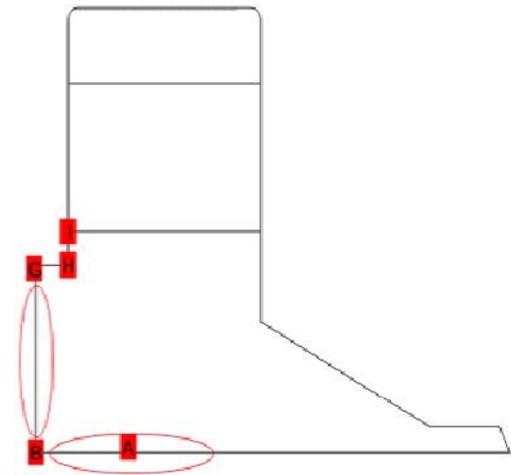
Figure 4. The internals of a raised face flange can be described as three connected zones

The corner edge of a flange is the transition from the bore of the pipe to the sealing surface of the flange itself (Position B Figure 4). Typically, in a raised face flange, the gasket which acts as a seal covers the area of the raised face from the corner edge to the end of the machined surface of the raised face. As such the corner edge is the start of the sealing face but edge corrosion is not an immediate threat to the integrity of the flange seal. Loss of the edge can create a crevice that allows for enhanced corrosion but as long as this is held at the edge position it does not pose a leak or integrity threat to the system beyond that experienced by the pipe itself.

The sealing face of the flange is the machined face that extends from the corner edge of the flange to the outer radius of the machined face. This area is covered by the area of the sealing gasket (Element B to G Figure 4). Corrosion damage of the sealing face is the critical factor in the integrity of the flange.
