### USE OF RPAS (DRONES) FOR MASONRY ARCH BRIDGES INSPECTION: APPLICATION ON GRAJAL BRIDGE

The bridge inspected was the “Puente del Grajal” (Fig. 1). It is a Bridge located at the following coordinates:

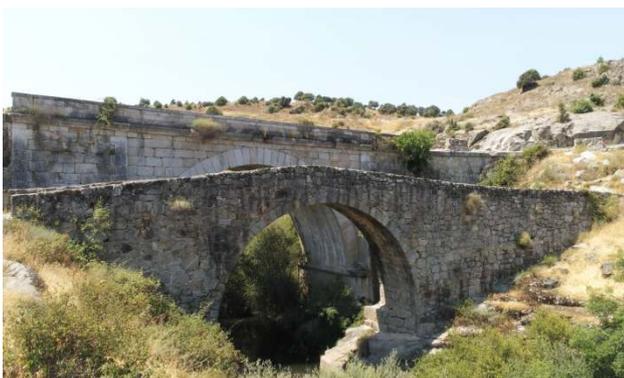
**Fig. 1:** Photograph taken with the drone used in the inspection, where we can see the Grajal Medieval Bridge, north elevation, with the nineteenth-century bridge behind it (photograph by the author)

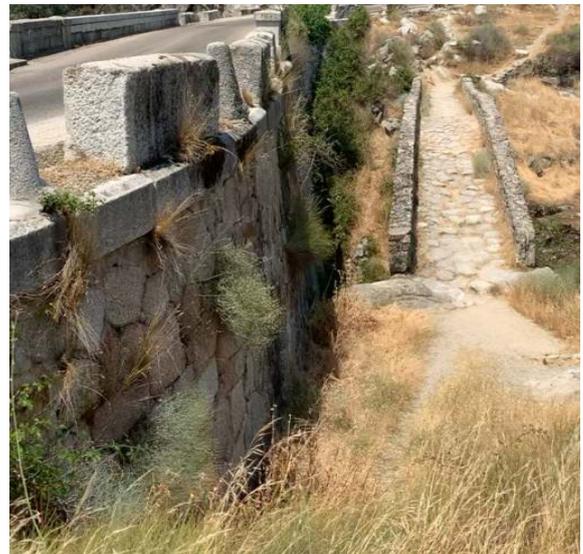
**Fig. 2:** Roadway over the medieval bridge (right) and traffic road over the nineteenth-century bridge (left). It gives an idea about the separation between the two bridges (photograph taken by the author)
