International Journal of Current Research Vol. 8, Issue, 07, pp.35114-35117, July, 2016 INTERNATIONAL JOURNAL OF CURRENT RESEARCH

AN ESTHETIC APPEAL TO THE TREATMENT OF AN OBLIQUE CROWN ROOT FRACTURE-A CASE REPORT

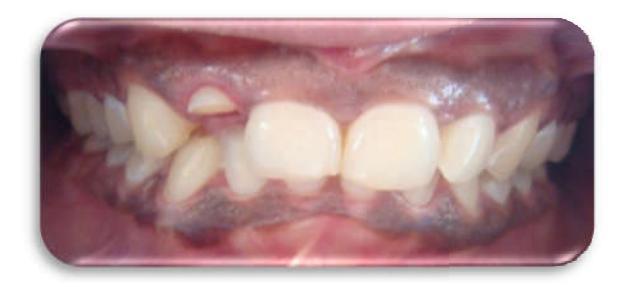
Figure 1. Ellis Class III Fracture with tooth 12 and Ellis Class I Fracture with tooth 1

A 28 yrs old lady reported with a chief complaint of broken upper front tooth 1 month prior to her visit to the department. She gave history of trauma due to a fall with a mild continuous pain. The patient's medical and family history was non contributory. There were no abnormalities in the hard and soft tissues on extraoral examination. On intraoral examination, tooth no.12 was fractured. Clinical examination revealed complicated crown fracture i.e., fracture involving enamel, dentin, cementum and pulp with tooth 12 and Ellis Class I fracture with tooth 11(Figure 1 & 2 .)The margins were 1.5 mmsupragingivally on the labial side and **2**mm subgingival on palatal side (Figure 3).

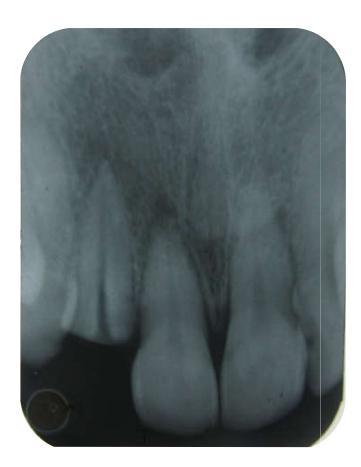
Figure 2. Radiograph showing Ellis Class III Fracture with tooth 12 and Ellis Class I Fracture with tooth 1

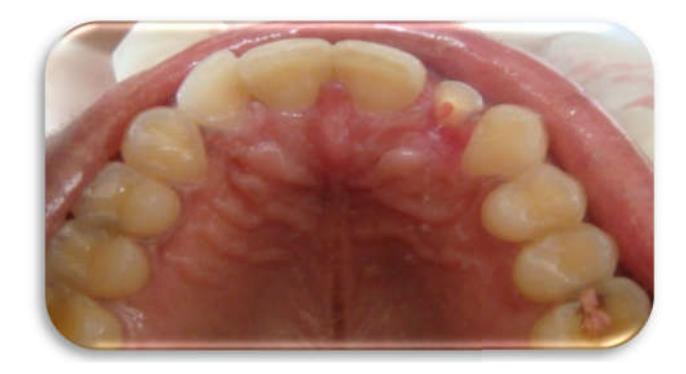
Figure 3. Palatal view of tooth 12

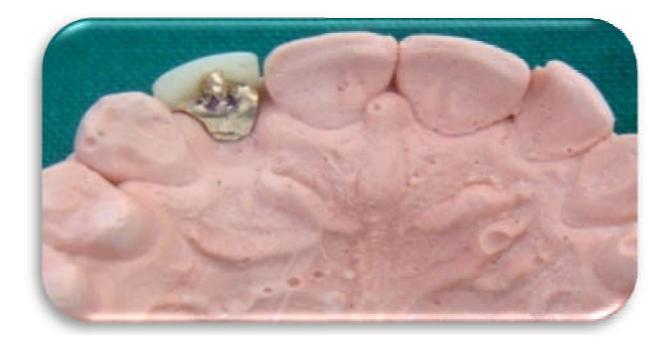
Figure 4. Modified cast post with hook and acrylic veneer

The post space was prepared upto12mm using peeso reamers of size 1, 2 and 3 (Mani- Prime Dental Products). With increasing demand for esthetics, modified cast post with a hook and a acrylic veneer (DPI-RR Cold Cure) attachment was fabricated (Figure 4).

To enhance esthetics, acrylic veneer was attached to cast post and hook assembly. Considering the time elapsed to follow up, the extension of fracture line, the amount of remaining root portion and patient's age, the present treatment plan was proposed. A combination of modified cast post and core with a labial veneer attached to it and orthodontic root extrusion has provided good functional and aesthetic outcomes. Clinical examination and radiographs showed satisfactory results during follow up which demonstrates the importance of establishing a multidisciplinary approach for a successful aesthetic management of dental trauma.

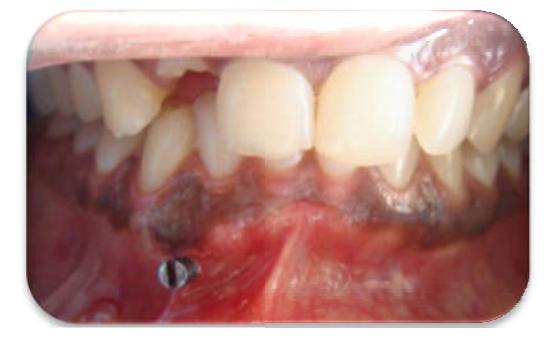
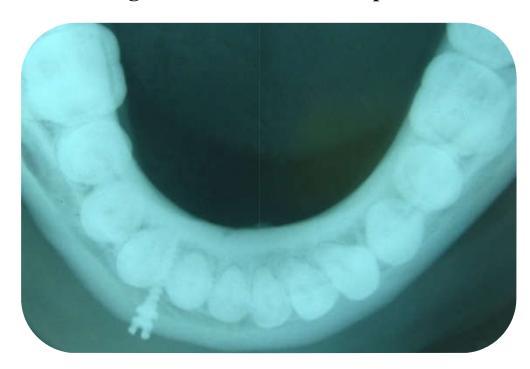
Figure 5. Placement of Implant

Figure 6. Radiograph showing placement of Implant

A mini implant of size 9 mm in length and 1.5 mm in diameter was placed in the mandibular arch between the roots of lateral incisor and canine. Approximately 6mm of the implant was placed inside the bone (Figure 5 & 6). Implant was placed directly in line with the long axis of the tooth and the hook for attachment of elastic would fall in line with crest of the tooth and would avoid any undesirable movement. The region of implant placement was inconspicuous and without disturbing esthetics. Post(Nordin, H Nordin SA, Chailly) was cemented using type I GIC (GC Corporation, Tokyo, Japan). The disadvantage of this method is that it is invasive procedure and technique sensitive. The success depends on oral hygiene maintenance.

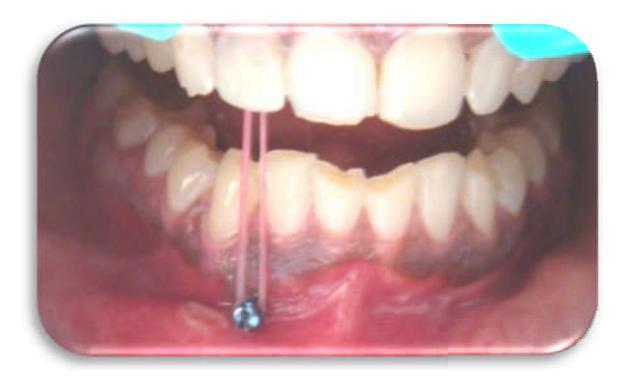
Figure 7. Extrusion of Tooth

The patient was advised to wear the elastics for a minimum period of 4 hrs daily, by engaging the elastic in the implant and the hook, resulting in pulling force which translates to extrusion of tooth (Figure 7). During every appointment the acrylic veneer was adjusted by trimming it to compensate for the amount of extrusion. After 8 weeks, 4mm of extrusion was observed (Figure 8). The hook of cast post was trimmed off and tooth was prepared and metal fused to ceramic crown was cemented with dual cure resin cement RelyX U100 [3M ESPE](Figure 9).

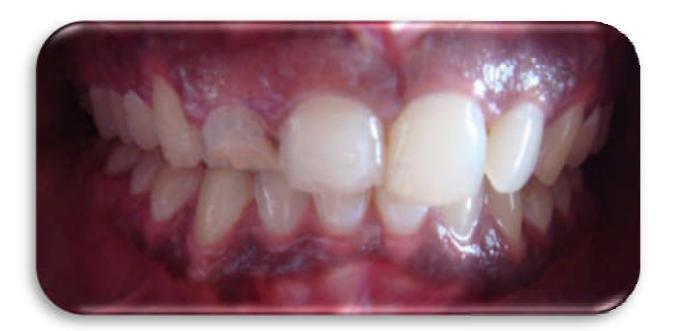
Figure 8. 4mm of Extrusion observed

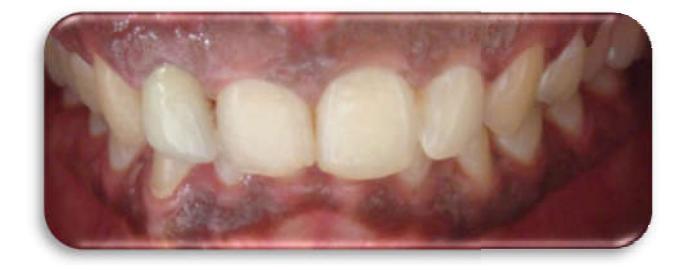
Figure 9. Metal fused to ceramic crown with tooth 12
